## Disaster Risk Reduction Lessons from February 7, 2021 Flash Flood in Uttarakhand Province of India

**Figure 1.** Location of Uttarakhand Province in the Map of India (Left), and the Catchment Area of Dhauliganga River in the Map of Uttarakhand, Depicting Drainage Network and District Boundaries (right).

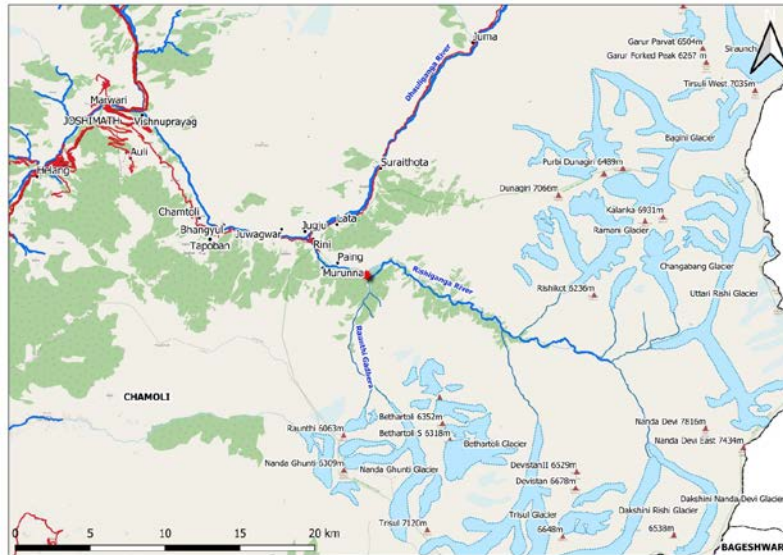
Figure 2. Map of Dhauliganga – Rishiganga Valleys

Dhauliganga River originates in the proximity of Niti Pass and flows southwest towards Rini, where it has its confluence with Rishiganga River which originates from the glaciers of Nanda Devi Massif and flows northwest. From Rini to Chamtoli (1.0 km downstream of Tapoban), Dhauliganga River maintains a tectonically controlled east-west course, and thereafter, flows southeast to meet

Alaknanda River at Vishnuprayag (Fig. 1). Dhauliganga valley exhibits rugged mountainous topography with high relative relief, and the altitudes range from 1450 to 7817 m (Mt. Nanda Devi). Geo-tectonically aligned narrow valleys and gorges are prominent geomorphic features of this valley that can be approached by Joshimath – Malari state highway.

Alaknanda Valley of Garhwal Himalaya has been particularly vulnerable to LLOF (Table 2), and 5 out of 15 (33%) reported incidences of river blockage in this valley, have been associated with Dhauliganga River (Figure. 2). Field evidences of

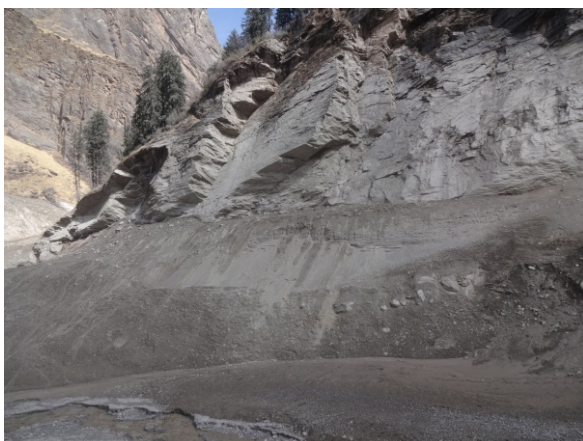
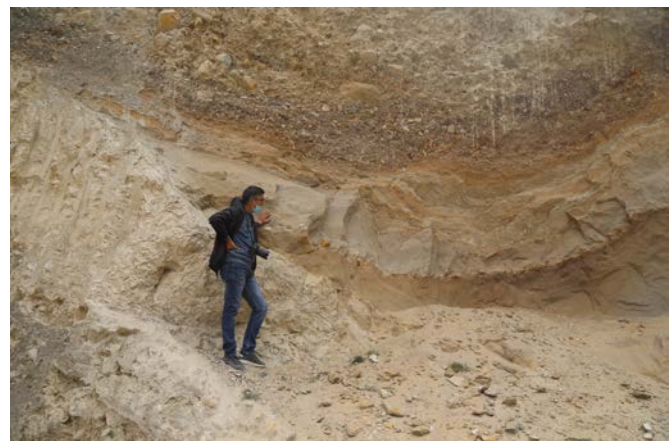
Figure 3. Lacustrine deposits on the right bank of Raunthi Gadhera near its confluence with Rishiganga River (left), and on the road close to hot water spring at Tapoban (right).

damming in the form of interbedded sequence of sand and pebbles have also been observed in this valley at two different places (Figure. 3). Dhauliganga valley is, thus, particularly vulnerable to flash floods.

Flood history of Dhauliganga River (Table 2) and evidences of previous damming in its catchment area (Figure. 3) have both been ignored, while planning the hydropower projects. Preparing a comprehensive inventory of previous disasters is

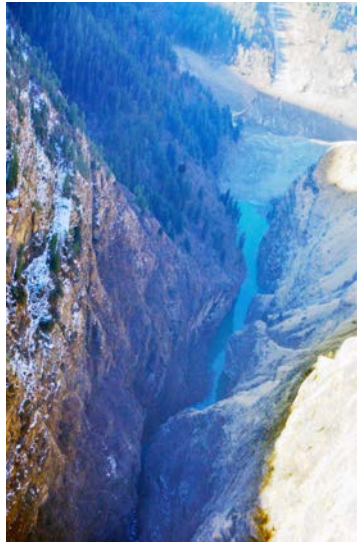
**Figure 6.** View of the Lake Formed in Rishiganga River on February 11, 2021.

Geomorphic changes brought forth by flood created a lake on Rishiganga River, close to its confluence with Raunthi Gadhera (Figure. 6). Having potential of LLOF, this lake was a major cause of concern after the flood, as it could jeopardize the safety of rescue workers at Tapoban. The debris barrier, however, breached naturally on February 12, 2021, and the threat was averted.
