# An Overview of Disaster Management during the April 25, 2015, Mw7.8 Nepal Earthquake

Mehdi Zare<sup>1\*</sup>

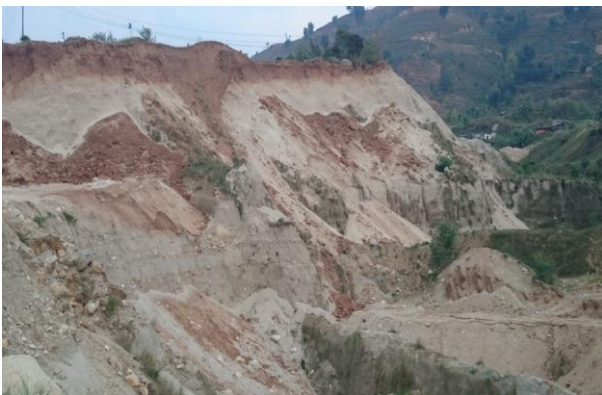
Following the 2015 earthquake, several earthquake-induced landslides, avalanches, ground fissures, and fault ruptures. Based on the observations, the earthquake triggered some new landslides along the intercity road from Kathmandu westward to Gorkha and Pokhara. At about 62 km west of Kathmandu, a relatively large landslide could be observed with an approximate size of 100m width \* 50m length (Figure 2).

**Figure 2.** An observed landslide with about 100m width and 50m length, 62 km west of Kathmandu.

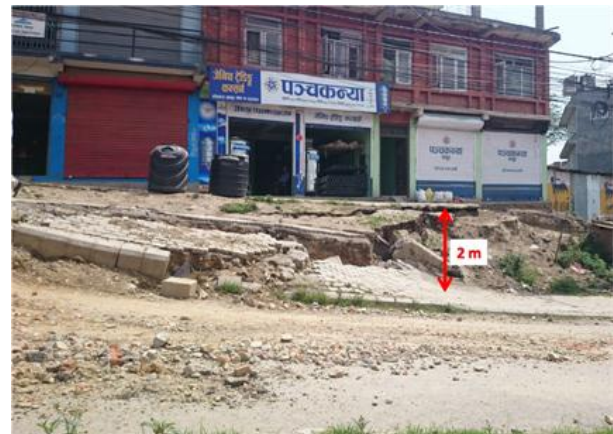
Because of the continued aftershocks occurred throughout Nepal in the first weeks, the country also had a continued risk of landslides. Moreover, the earthquake sparked an avalanche on Mount Everest and a huge avalanche in the Langtang valley, blocking mountain routes, killing several individuals and missing hundreds. Furthermore, a typical ground fissure was observed at a distance of about 9 km southeast of Kathmandu toward Bhaktapur with a NE-SW direction and 2-meter vertical displacements (Figure 3).

**Figure 3.** A typically observed ground surface fissure with NE-SW direction between Bhaktapur and Kathmandu.

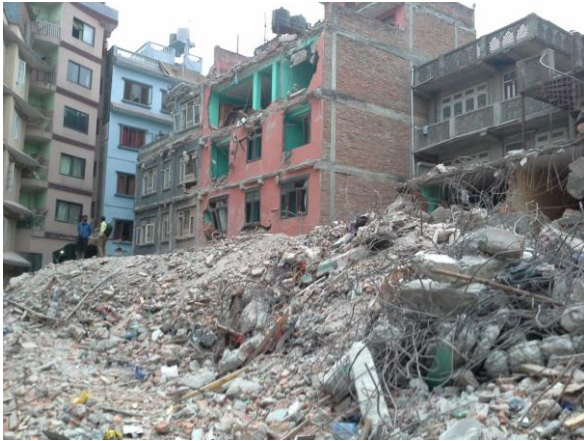
In all the visited areas, there were many low-resilient buildings that were fully collapsed, tilted or severely damaged. The fourteenth day after the earthquake, large amounts of debris from destroyed buildings were not cleaned, making the affected areas to be so unsightly and polluted. The destructions in Gorkha District as well as Langtang village in a 60-kilometer distance northeast of Kathmandu. In Kathmandu, Unfortunately, disorganization and confusion in some developed regions were more evident than other less developed regions. For instance business and shopping centers and residential complexes sustained major damages (Figure 4).

**Figure 4.** Severe damages to the building in Kathmandu.

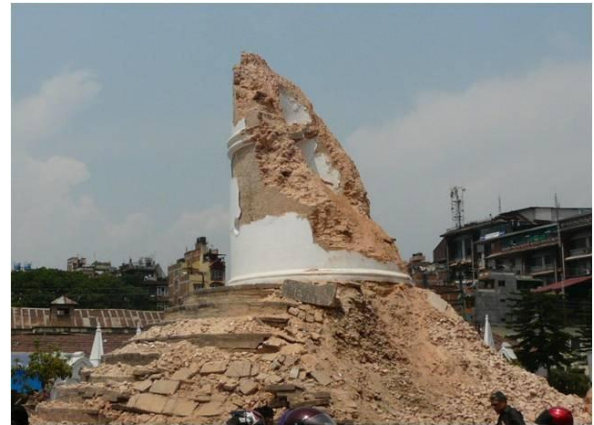
**Figure 5.** Destroyed historic/cultural world heritage Durbar Square of Kathmandu

The 2015 Gorkha earthquake almost destroyed all the world heritages in the Durbar square of Kathmandu, as well as the 183-year-old nine-storey Dharahara tower at the center of Sundhara (**Figure 5**). A similar situation was observed in the Bhaktapur Durbar Square situated about 12 km southeast of Kathmandu (**Figure 6**). Visiting the Swayambhunath Buddhist temple (also known as the Monkey Temple) (**Figure 7**), some important parts of the temple and one of its adjacent towers were found to be destroyed.

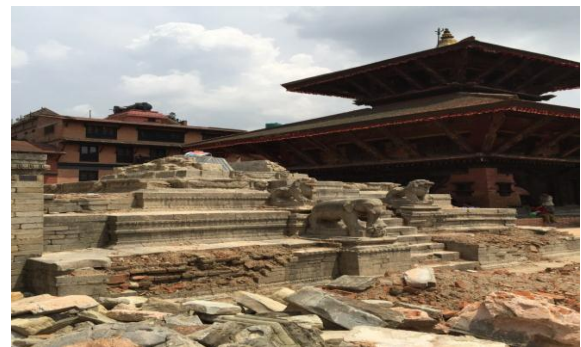
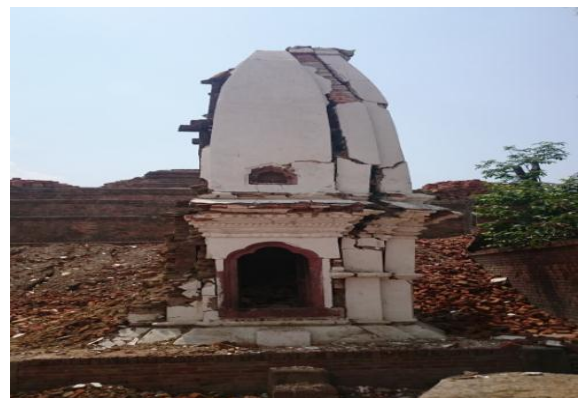
**Figure 6.** Destroyed historic monuments at Durbar Square of Bhaktapur.

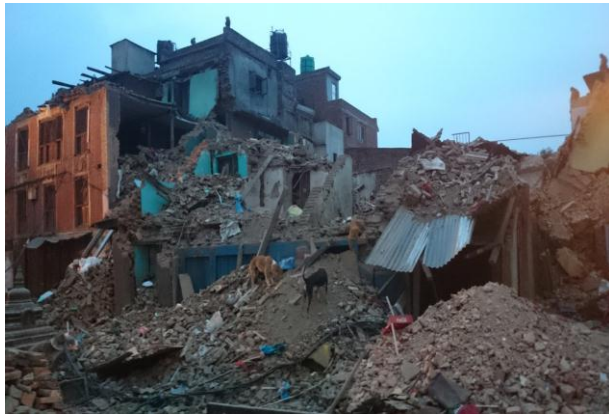
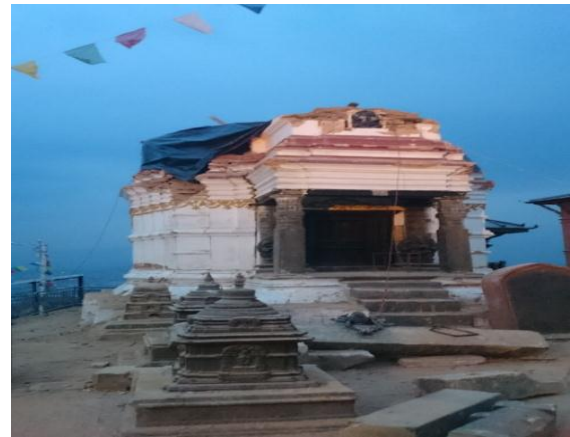
**Figure 7.** Damaged Swayambhunath Buddhist temple west of Kathmandu.

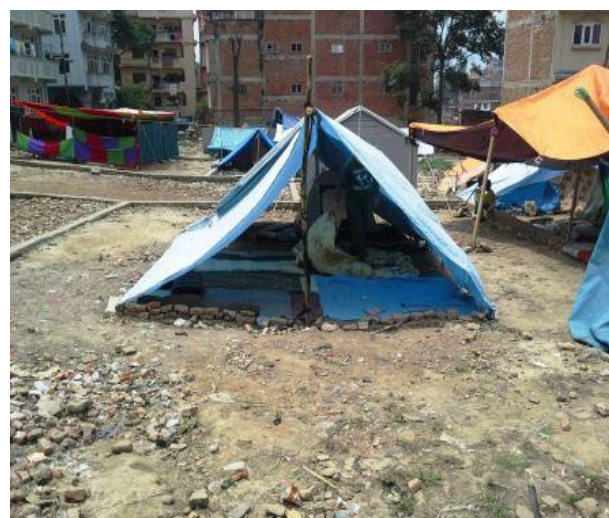
**a):** If the private damaged houses did not collapse fully and it was possible to bring the essential appliances outside, the owners tend to stay beside their houses; so they set up their temporary shelters next to their houses. Most of these emergency temporary shelters were only plastic sheets that were distributed throughout the cities and people themselves had set them up as tents without side walls using remained bamboo reeds and wooden beams of their houses (**Figure 10**). A large number of these kinds of emergency shelters were observed in which there were no basic hygiene amenities such as toilets and bathrooms. The residents refuted to these tents only at night or during rain. The Food and clean drinking water were provided by the affected people themselves in an extremely difficult way and there was no humanitarian assistance in these shelters.

**Figure 10.** Handmade temporary tents that owners had made using plastic sheets, bamboo reeds and wooden beams beside their houses in urban areas.

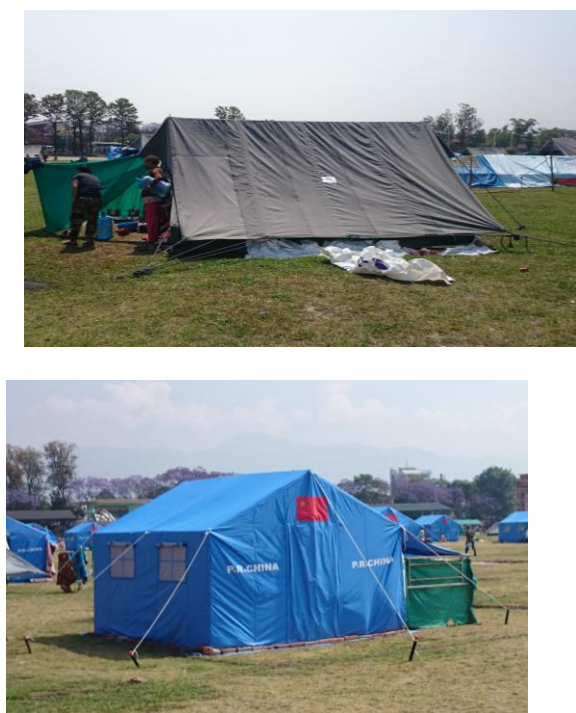
Kathmandu and Bhaktapur, two types of tents donated by China and India were used. It was observed that the Chinese tents had better quality and design than the Indian ones. All the Chinese tents were made of resistant steel frames with a two-layer cover, a surface waterproofing cover and an internal thermal insulation cover, while the Indian tents were made of a single layer canvas cover. With regard to the weather conditions in Nepal such as cold winter and heavy rainfall, the quality of the used tents is very important for the residents of the camps. Although the Chinese tents had a very good quality, unfortunately they were not set up correctly in Kathmandu so the rainwater had penetrated into the tents and all parts of the tents and also the clothes got wet (**Figure 11**).

**Figure 11.** Emergency tents in public camps of Kathmandu and Bhaktapur donated by China (Right) and India (left)

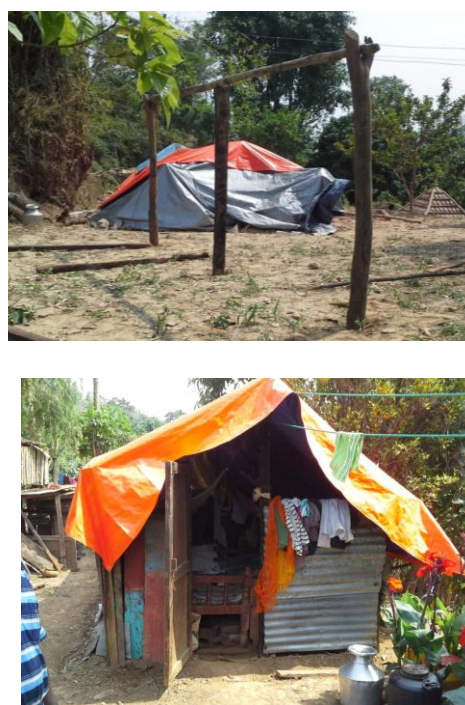
plastic covers were distributed instead of tents. In order to set up temporary shelters in these villages, some people had made frameworks using bamboo trunk which were covered by plastic sheets. Most of these shelters lacked side walls and would simply be blown away by the first gust of wind. Some of the villagers skilled in carpentry and masonry often tried to build very basic cottages using the remaining materials of their building debris. Most of these houses had a wooden skeleton with bamboo straw sidewalls. Doors and windows of the destructed houses were also used as the doors and windows of the new houses and metal corrugated sheets or plastic coating were used to cover the ceiling (**Figure 12**). In none of these villages, there were no appropriate tents such as tents which were installed in the cities of Kathmandu and Bhaktapur.

**Figure 12.** Handmade temporary tents that owners had made using remained parts of their houses in rural areas.

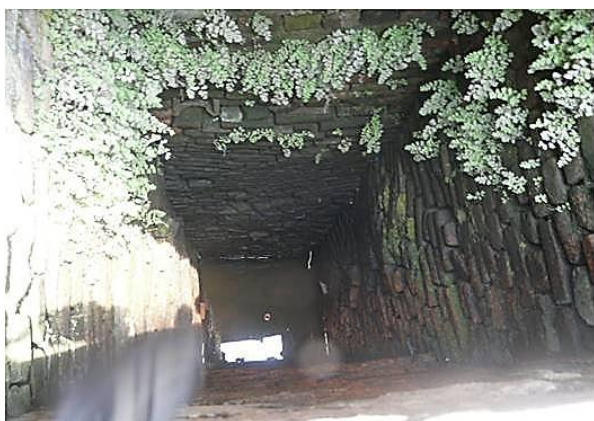
**Figure 13.** Groundwater level mostly in western parts of Kathmandu with about 3-6 meter depth.

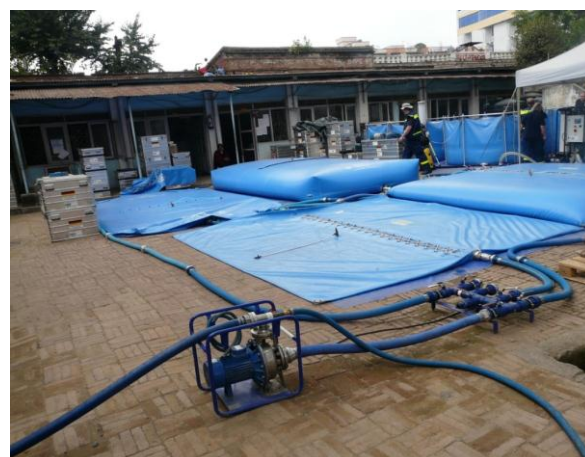
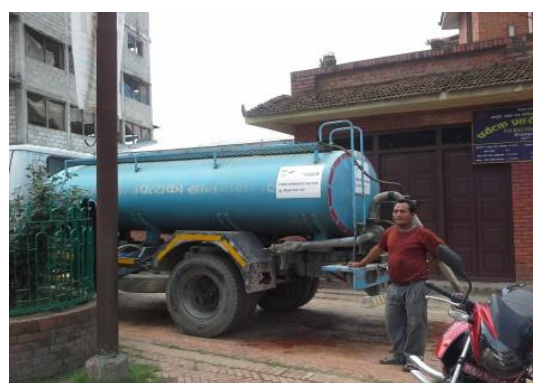
of their water filtration system into 120,000 Lit/day but there were not enough facilities to distribute even that 10,000 Lit/Hour of clean water. Kathmandu's Water Organization had promised the German team to have 5 trucks to distribute clean water daily, but actually, less than 5 trucks were available. Without the occurrence of an earthquake, Kathmandu is a city where there are so polluted water supplies extracted from wells. Moreover, about 360 million liters of clean water are needed per day; while only 130 and 90 million liters of clean water are daily available in rainy and dry seasons respectively. In Bhaktapur, water was extracted from in-situ wells (**Figure 15**) and was refined and distributed by the German team.

**Figure 14.** Providing treated water in the Water Organization of Kathmandu by a German specialist team and distribution of it throughout the city by trucks.

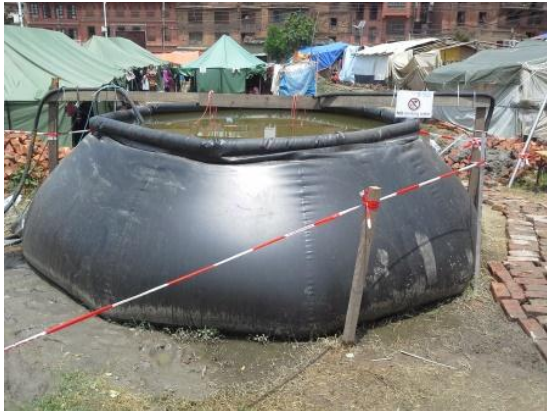
**Figure 15.** Providing treated water in Bhaktapur from extracted water of in-situ wells by a German team.

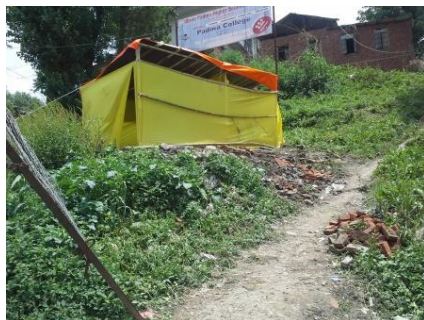
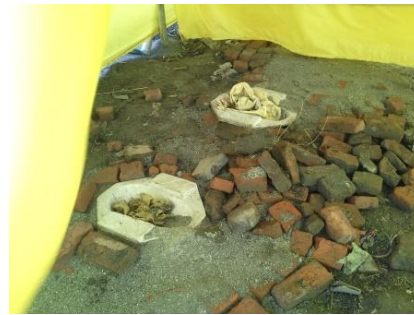
In the camp of Kathmandu, residents had to use the public restrooms of Tundikhel Parade, while these services lacked appropriate quality and standards. In the camp of Bhaktapur, two emergency health services were initially set up which were closed during the first week of use, due to the wrong location of these two services (up of the slope toward the camp), and the wastewater penetrated into the camp. After a while, the health services installed for tourists were used instead (**Figure 16**).

**Figure 16.** Prepared health services in the public camp of Kathmandu.

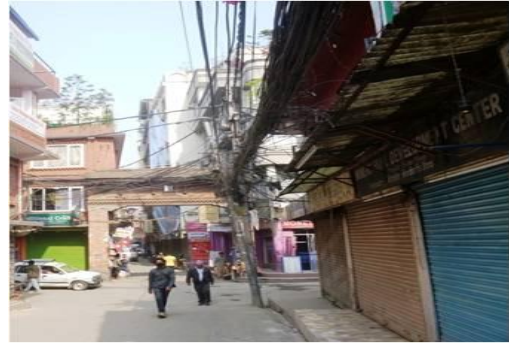
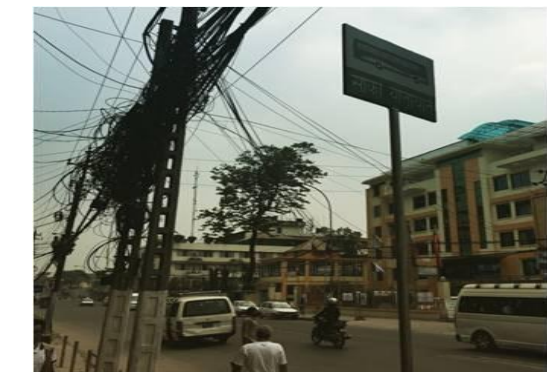
There is a complicated and dangerous wire system transmitting electric power in Kathmandu (**Figure 20**).

**Figure 20.** A dangerous and complicated power wires system in Kathmandu
